**NATIONAL REGISTER OF HISTORIC PLACES
REGISTRATION FORM**

HISTORIC NAME: Carrizozo Woman's Club
OTHER NAME/SITE NUMBER: Woman's Club of Carrizozo

Carrizozo Woman's Club
Carrizozo, Lincoln County, New Mexico

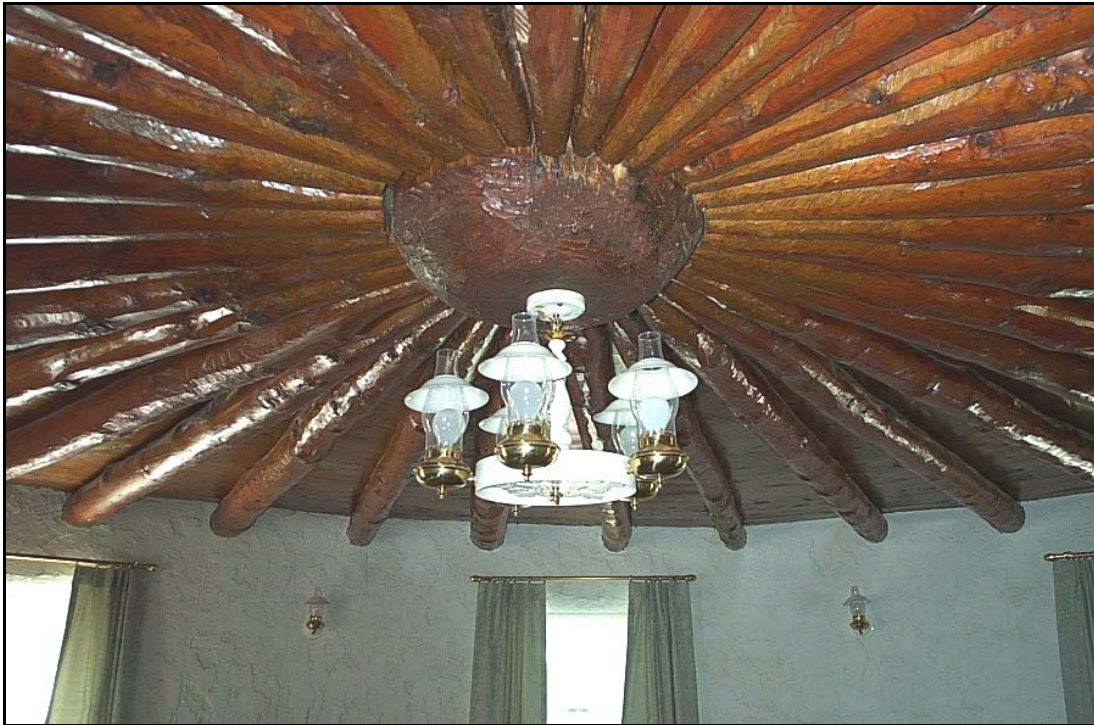
Figure 7-1 **Beamed Ceiling of Round Room; Facing Southwest (2002)**

The Round Room is unique among NMFWC buildings constructed during the New Deal. Designed by Jess C. Garrison, the foreman of the Works Progress Administration (WPA) crew who constructed the building, the circular room is used for meetings and banquets and contains a brick fireplace located along its inner circumference. Accessible from both the kitchen and the main hall, the room extends 30 ft. in diameter with a ceiling containing exposed vigas radiating from a rounded central log from which a chandelier also hangs. Suggestive of an oversized wagon wheel with multiple spokes radiating from a large wooden hub, the vigas support a ceiling consisting of 1x6" tongue-and-groove boards cut at varying lengths and angles to effect a latilla-like appearance (see Figure 7-1). The support for this intricate design is located in the approximately three ft. crawl space located above the ceiling. There are a series of perpendicular wood beams and steel plates are bolted together, creating a series of trusses that support the central hub; 3/16" steel wires augment the trusses.

When the first job foreman left the community soon after the project started, Jess C. Garrison, a local builder, replaced him. According to WPA records, the town was to provide the plans for the project. In order to devise a plan, club members visited the nearby Alamogordo Woman's Club, where a community hall and clubhouse had been completed as a WPA project in 1937. Typically, these buildings included a main hall for meetings and public events, one or more meeting and sitting rooms and a large kitchen. Most likely shaping a consensus, club members worked with Garrison to develop a plan that included a second large meeting room that would be circular. Despite some skepticism regarding his ability to construct a round room using vigas but no central support post, Garrison fashioned the room, designing an intricate truss system that he installed in the crawl space above the ceiling. Nearly three-quarters of a century after its construction, the Round Room ceiling continues to convey the design ingenuity and workmanship of Garrison and his WPA crew.
